Bulletin Number: DF 4-04

Burner Supply Tube Compression Fitting Nuts

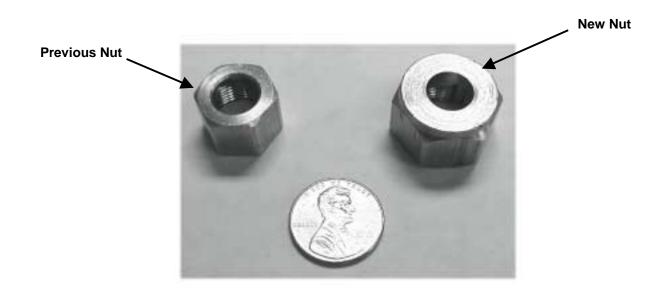
We have received complaints from several customers that the burner supply tube compression fitting nuts have cracked on some units after a season or two of use. These are the fittings that connect the low pressure copper tube to the burner. The cracks are developing as a result of thermal stress in severe environments.

As a result, Algas-SDI has initiated the use of a heavier duty compression fitting and nut. The new nut requires the use of a 13/16" open-end wrench or flare-nut wrench for servicing, whereas the previous nut required a 5/8" wrench. The new nut has an increased wall thickness of 0.10"
