Bulletin Number: DF 10/03

Main gas lock-in with Robertshaw thermostatic gas valves

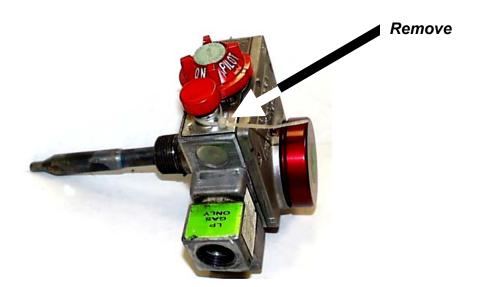
Problem: Pilot ignites ok but will not stay engaged once the override button is released.

<u>Resolution:</u> Remove plastic zip tie connected to tag that is located at base of safety interlock override button. This zip tie will prevent the override button from being depressed far enough to allow proper lock-in.

This tag has been relocated on units manufactured after September 2003.
